T53 Engineering Product Support Notice – PT Bearing Heat Shield Repair

March 16, 2023

Air Technology Engines (ATE) Repair Instruction

PT Cover, Exhaust Diffuser, 1-140-182-01

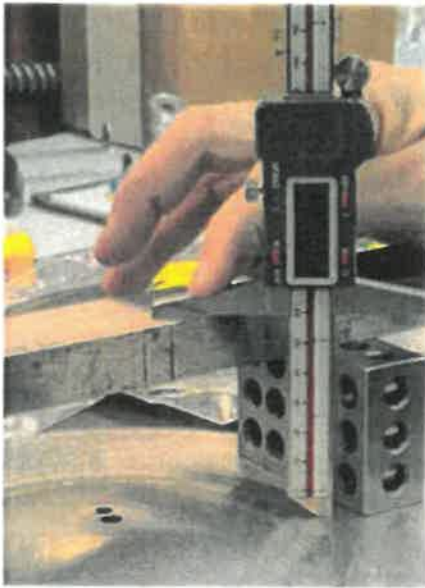
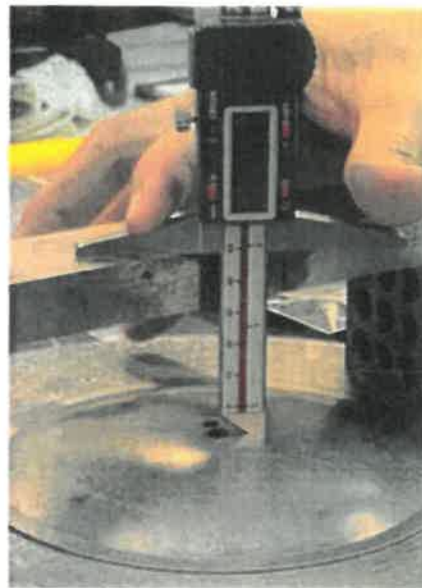
Recommended Method of Inspection - Dimension A

1. Remove 1-140-182-01 PT Cover. Removal of 1-140-640-03 Rear Bearing Cover is Optional.
2. Inspect PT Cover 1-140-182-01 for dimensional and physical inspection. If physical surface damage is evident (bolt hole edge wear, outer circumference contact surfaces fretted and worn, bolt hole edge cracks i.e.) replace part. (No cracks acceptable)
3. PT Cover 1-140-182-01 Height -Dimension A, (See Illustration) Measure height from outer flange to raised center surface of PT Cover, record results as Dimension A in table provided.

PT Cover (Heat Shield)
1-140-182-01

(A) .392
.408

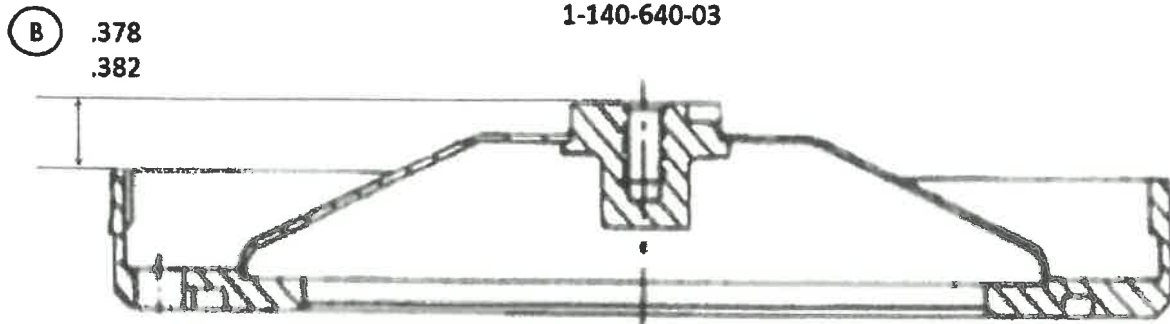
4. Rear Bearing Cover 1-140-640-03 Dimension B, (See Illustration) Measure height from outer rim to center of bearing cover and record as dimension B. NOTE: This can be accomplished with the rear bearing cover installed or removed from the engine (Shown as removed).
